**RE: Administrative Summary - Phase II Archaeological Research
SugarHouse Casino Property
Philadelphia County, Philadelphia, Pennsylvania**

On December 21, 2007, A.D. Marble & Company completed the Phase II Archaeology Survey at the proposed location for the SugarHouse Casino in the City of Philadelphia.

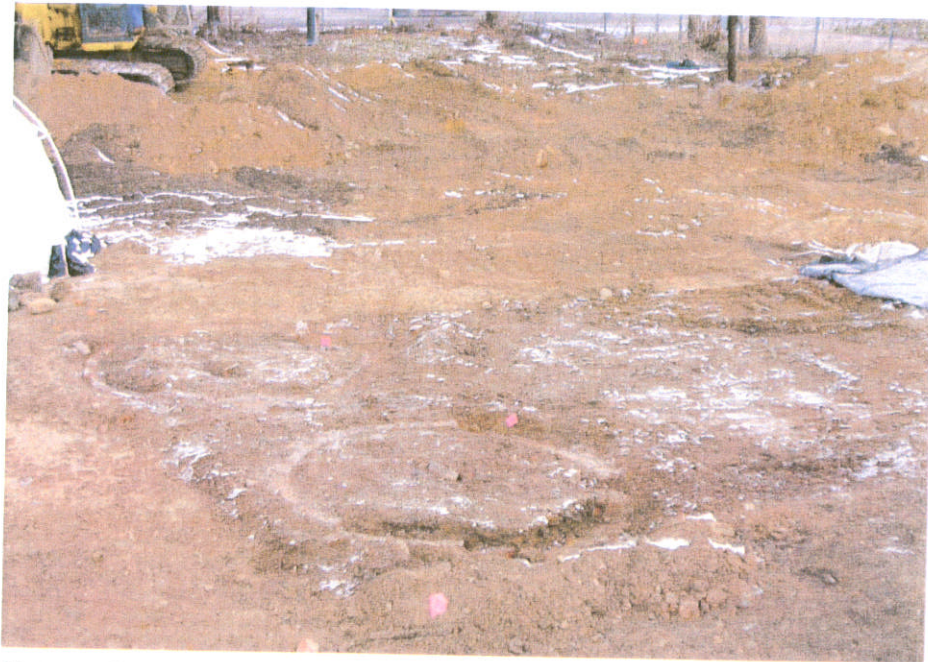
Photograph 1: View to the east showing the tops of Shaft Features # 127 and 128 (December 2007).

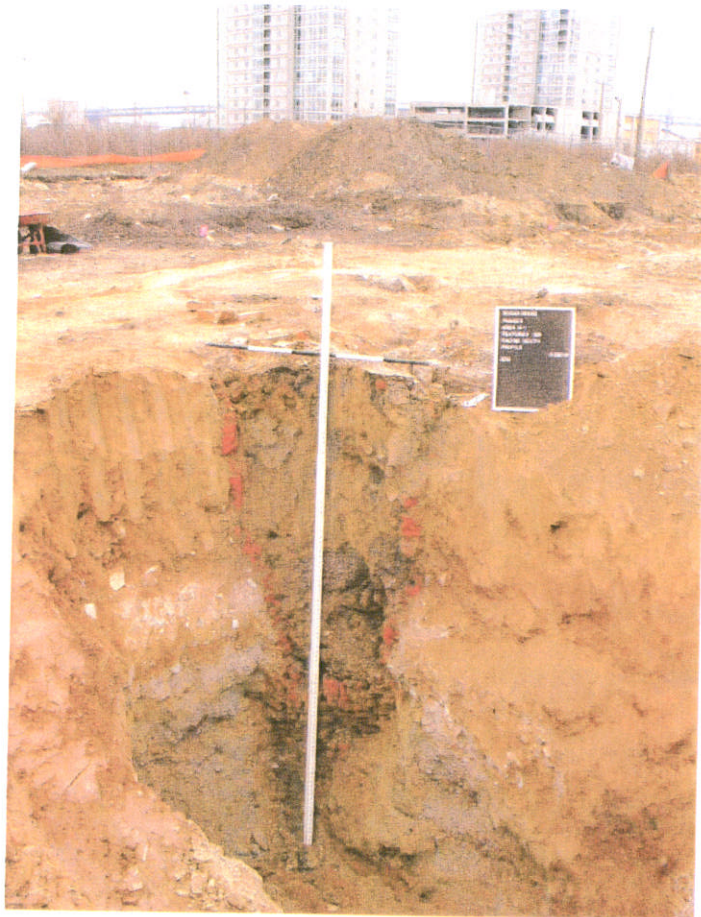
Photograph 2: View to the southeast showing the excavated portion of Shaft Feature 125. The portion of the feature with archaeological integrity begins at the 5-foot mark and continues downward (December 2007).

During the Phase II field work, all shaft features were individually mapped and photographed. Subsurface testing was undertaken to establish the integrity of the shaft feature contents and to record their depths below surface. A portion of each feature was investigated through hand excavation and mechanical means when archaeologically appropriate. Of the 19 shaft features identified, six have been found to contain historic artifact remains of contextual and stratigraphic integrity. Photographs 1 and 2 show the typical horizontal manner in which the shaft features were found and the manner in which they were investigated. It should be possible to link these artifacts with particular residential lots and thereby with individual owners or inhabitants of those properties. We believe that four of the six shaft features containing significant historic remains will provide artifact material that will date to the mid 19th to early 20th century. The other two shaft features appear to contain artifacts from the mid 18th to early 19th centuries.

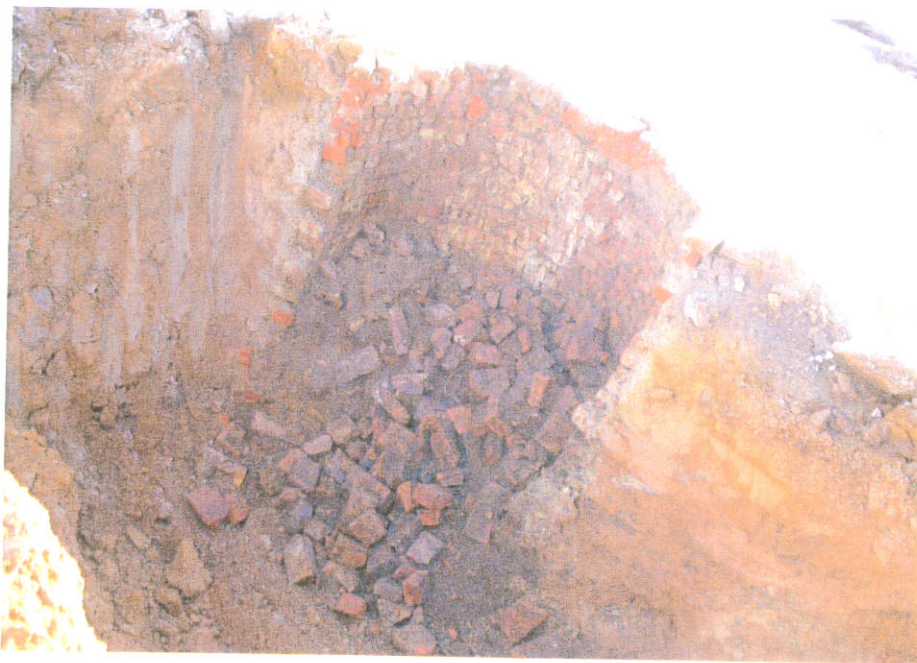
Photograph 3: View to the east of the debris that filled Shaft Feature 137 (December 2007).

The rest of the 13 shaft features contained no archaeological deposits of significance. These features were primarily devoid of artifacts and filled with the same demolition debris, brick rubble, coal cinder and coal ash that characterizes the upper soil conditions that existed across the area covered by Historic Area H-1. Such conditions are shown in Photographs 3 and 4 which detail the type of infilling encountered during the investigation of these features. We believe that these features had been cleaned out prior to their infilling with demolition debris. Additionally, the six shaft features considered to have archaeological integrity also contain similar demolition debris and fill within the upper portions of their fills.

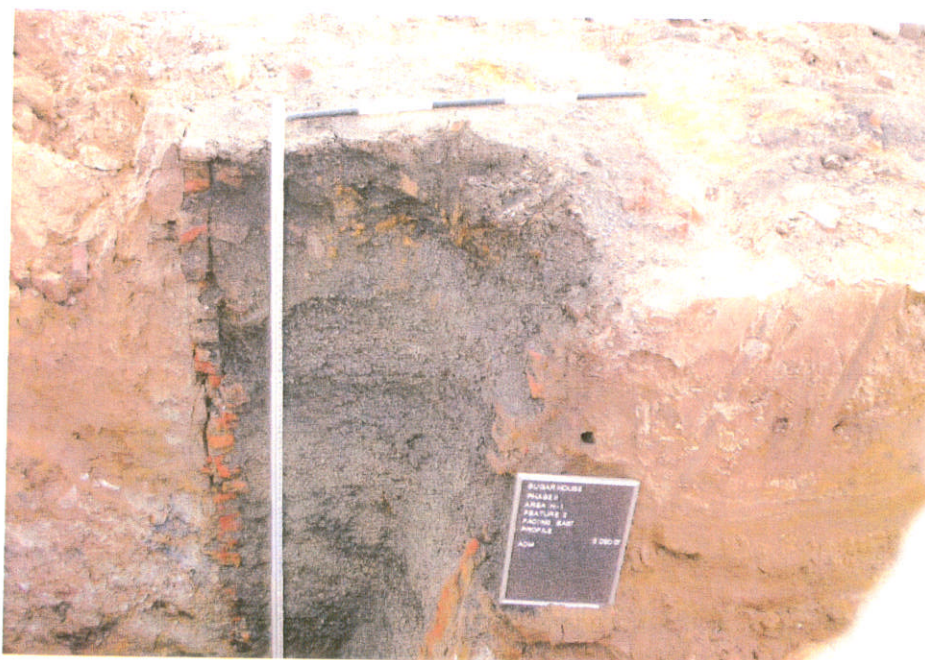
Photograph 4: View to the south showing the coal, coal ash, and cinder fill that exists within Feature 2 (December 2007).
